The Fire of Autotransformer as Result of 400 kV Bushing Explosion

Dr. Anatoly Shkolnik

Engineering Consulting & Supervision

Electricity 2017

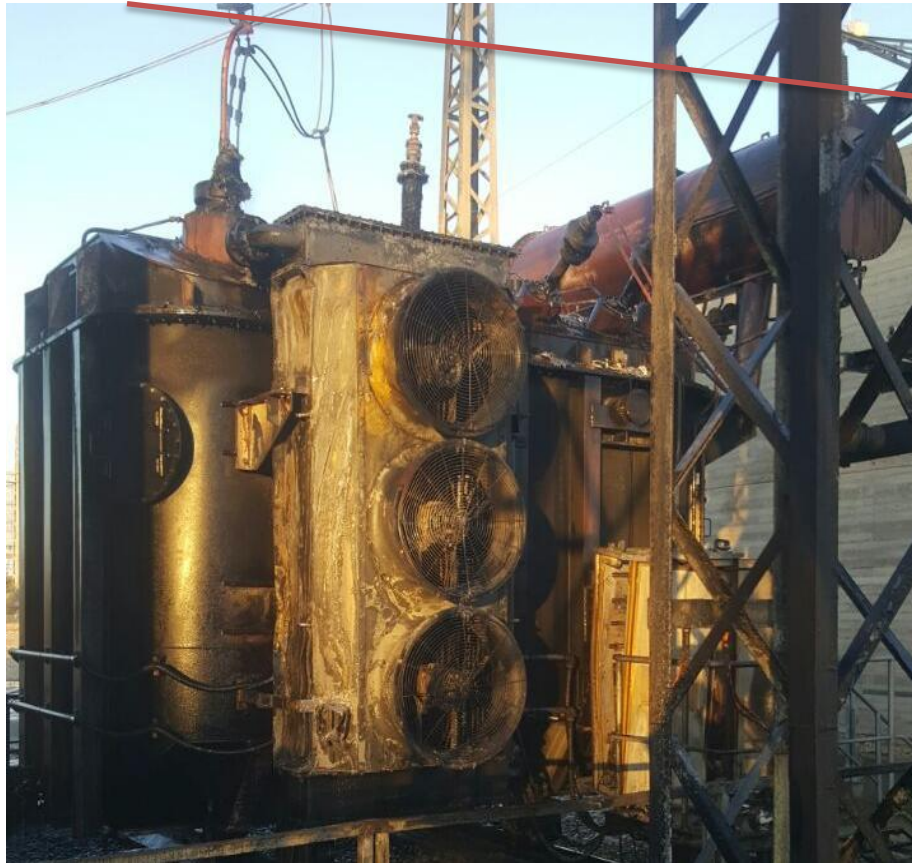
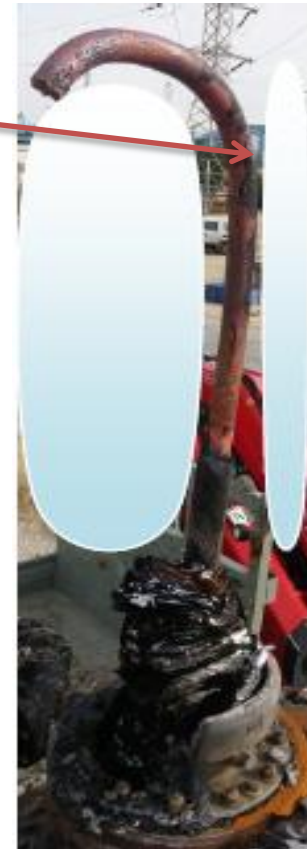
Explosion of the 400 kV Bushing in a Single-Phase 167 MVA Autotransformer

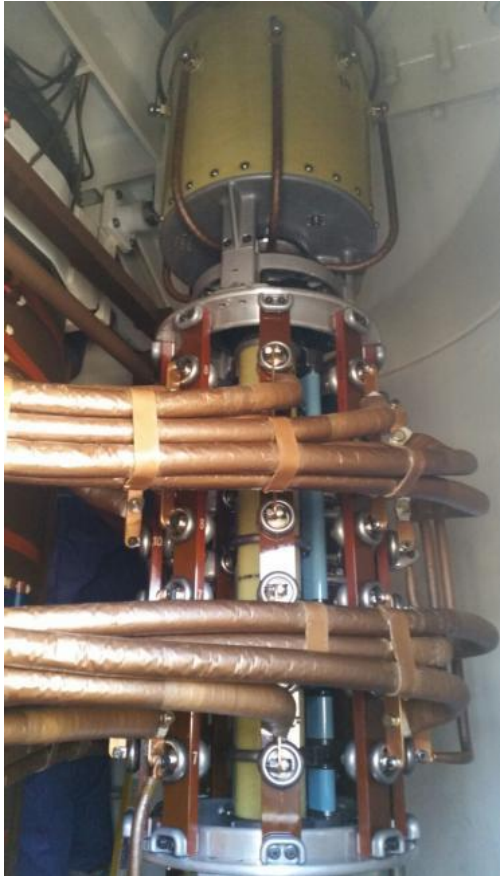
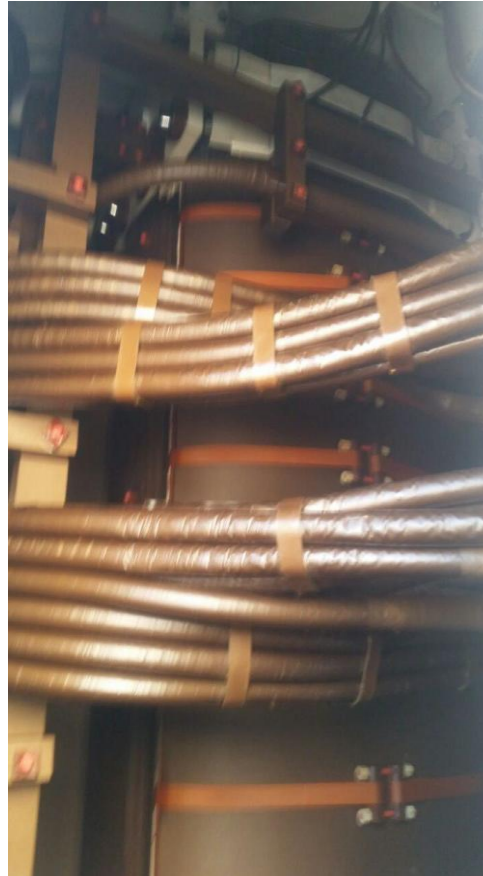
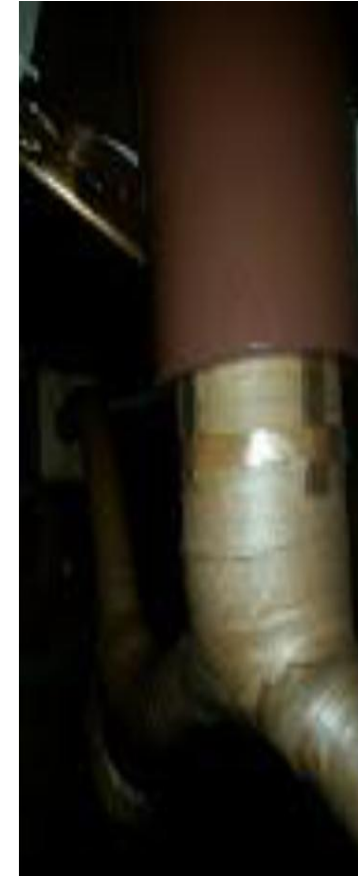
The active part of the autotransformer after fire

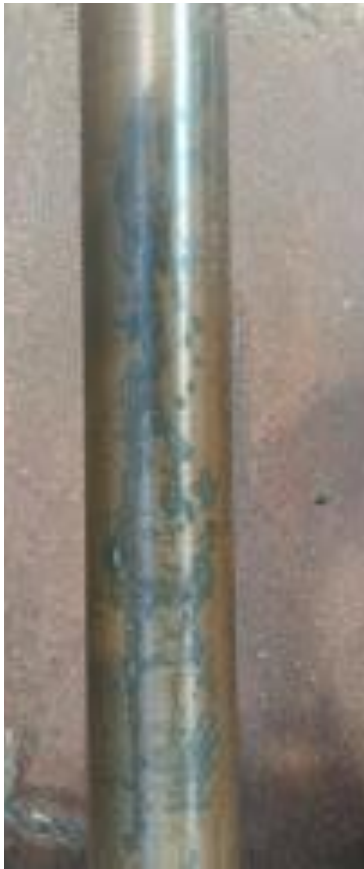
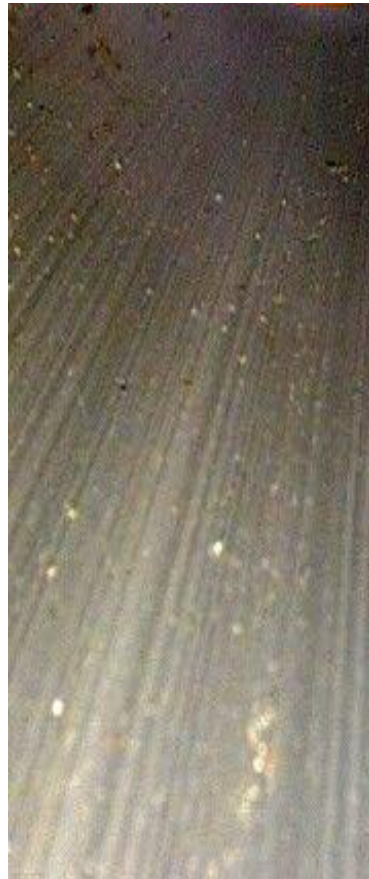
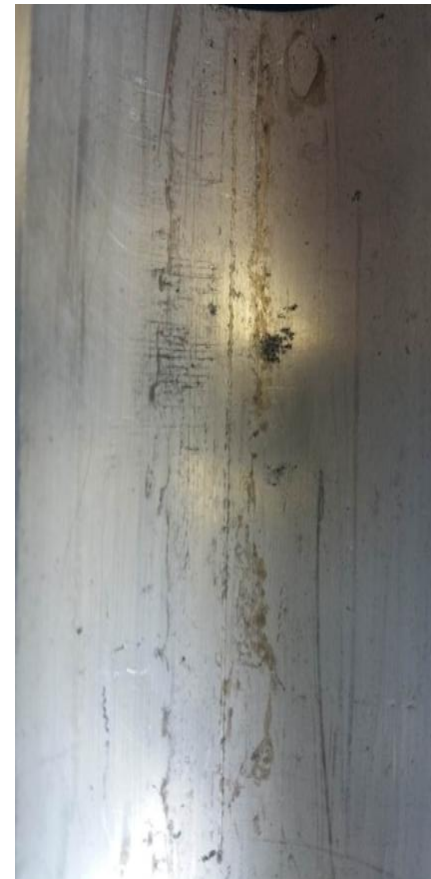
Tracks on bottom part of copper rod and on inner surface of the aluminum tube

- Due to network and substation overvoltage, micro arcs arise between the rod and the tube.
- The magnitude and location of these micro arcs are random and depend on many factors:
 - The amplitude of the wave (transient overvoltage).
 - Its time characteristics.
 - The electrical parameters of the autotransformer.
 - The electrical devices (arrester, cable or air lines, switchgears and disconnectors, etc.) attached to it.
