The Fire of Autotransformer as Result of 400 kV Bushing Explosion

Dr. Anatoly Shkolnik

Engineering Consulting & Supervision

Electricity 2017

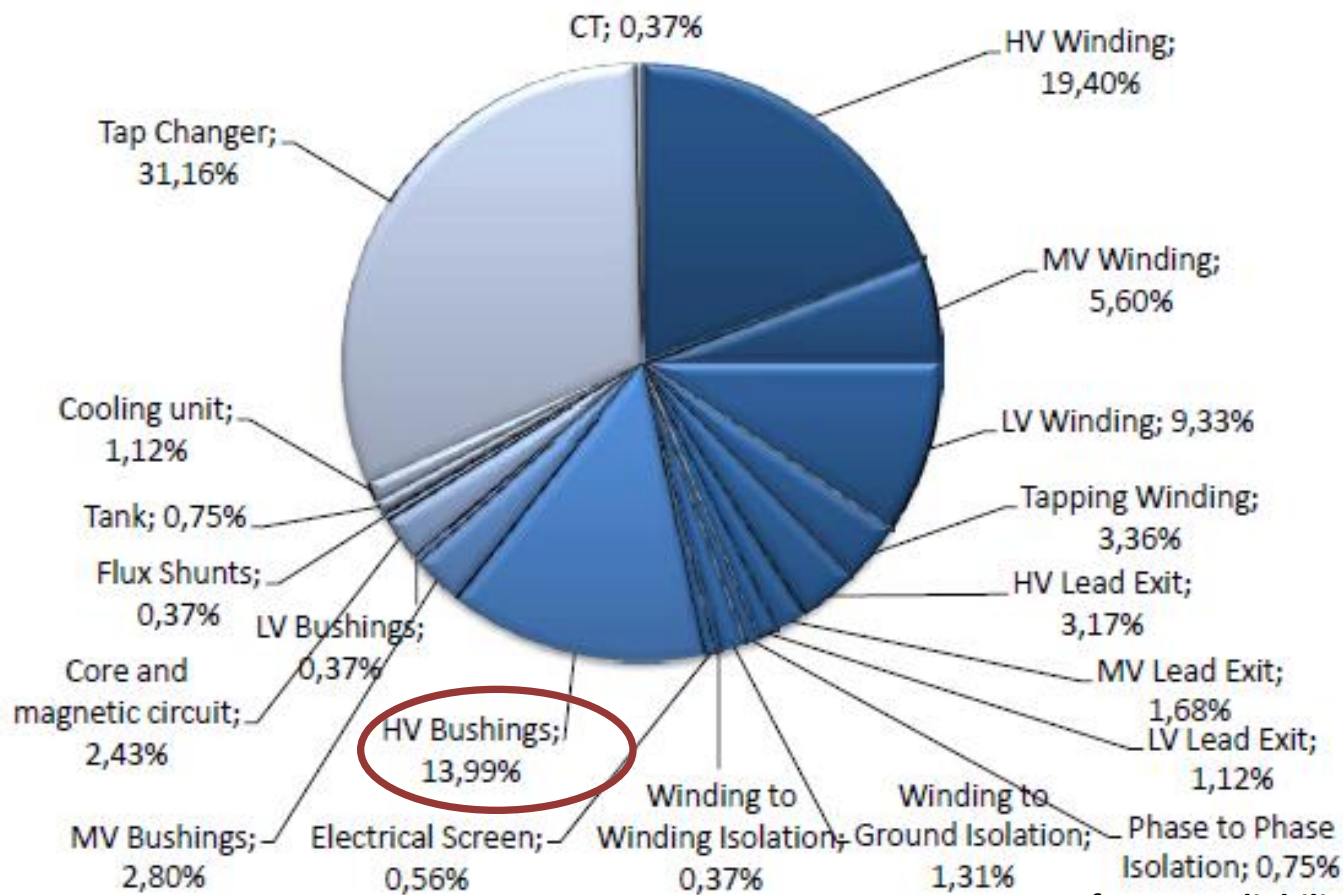
**Failure Location
Analysis,
Substation
Transformers,
U ≥ 100KV, 536
Failures**

14% of substation transformers failures are due to HV Bushings

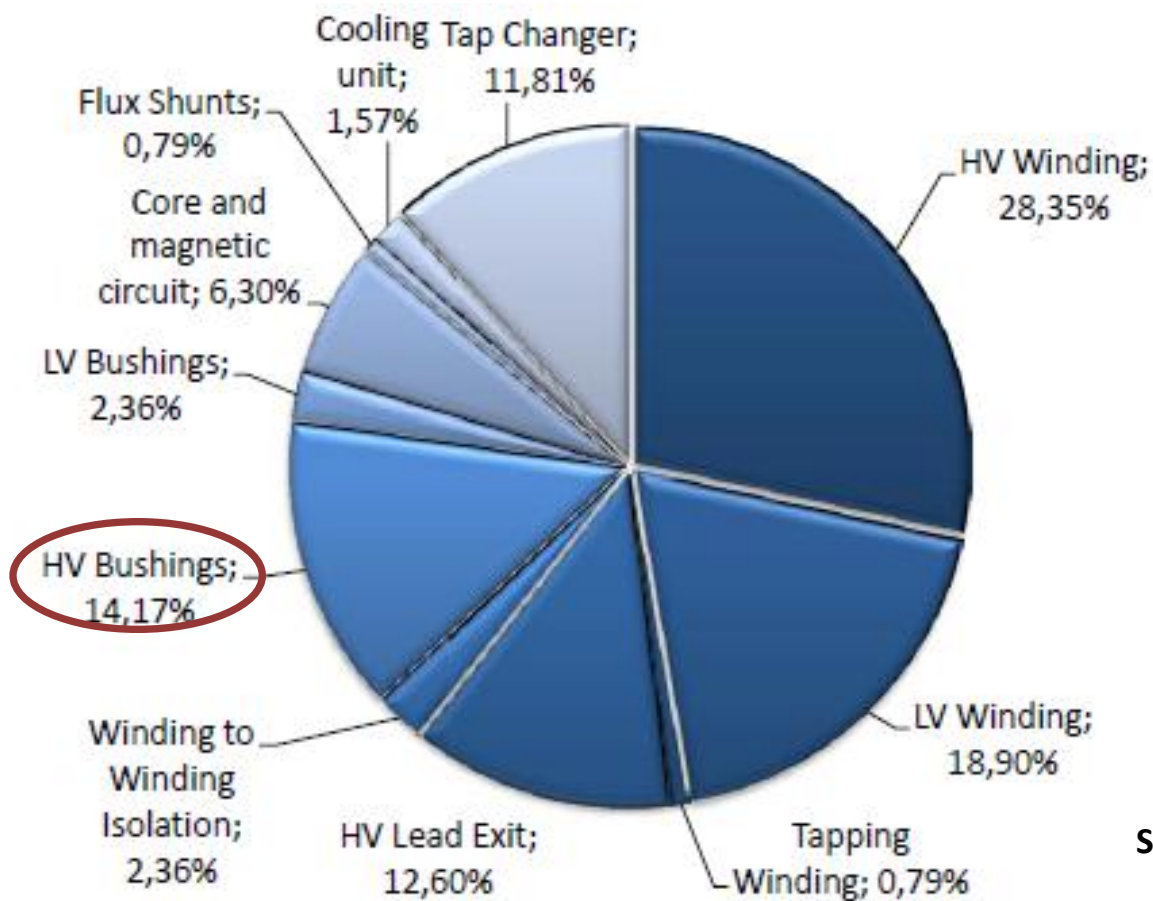
**Failure Location Analysis,
Generator Step-up Transformers,
 $U \geq 100\text{KV}$, 127 Failures**

14% of Generator Step-Up Transformers failures are due to HV Bushings

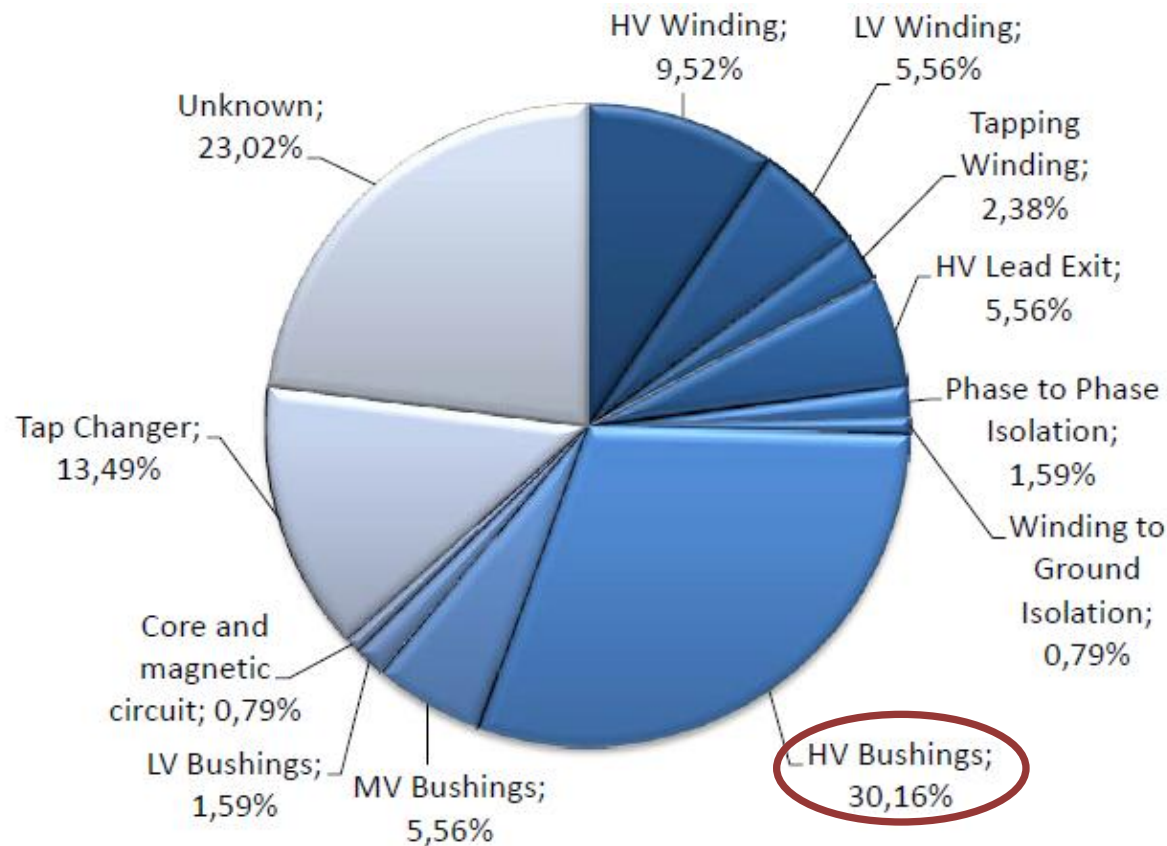
**Failure Location
Where Fire or
Explosion
Occurred, 126
Major Failures**

30% of Failures where fire or explosion occurred are due to HV Bushings

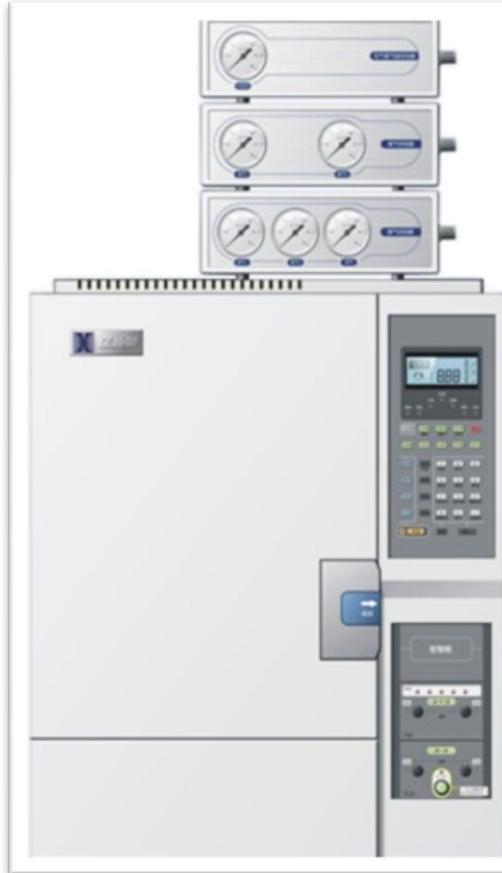
Dissolved Gas Analysis (DGA) can detect early signs of arcs/sparks in oil

Solutions: Regular DGA and Insulation tests

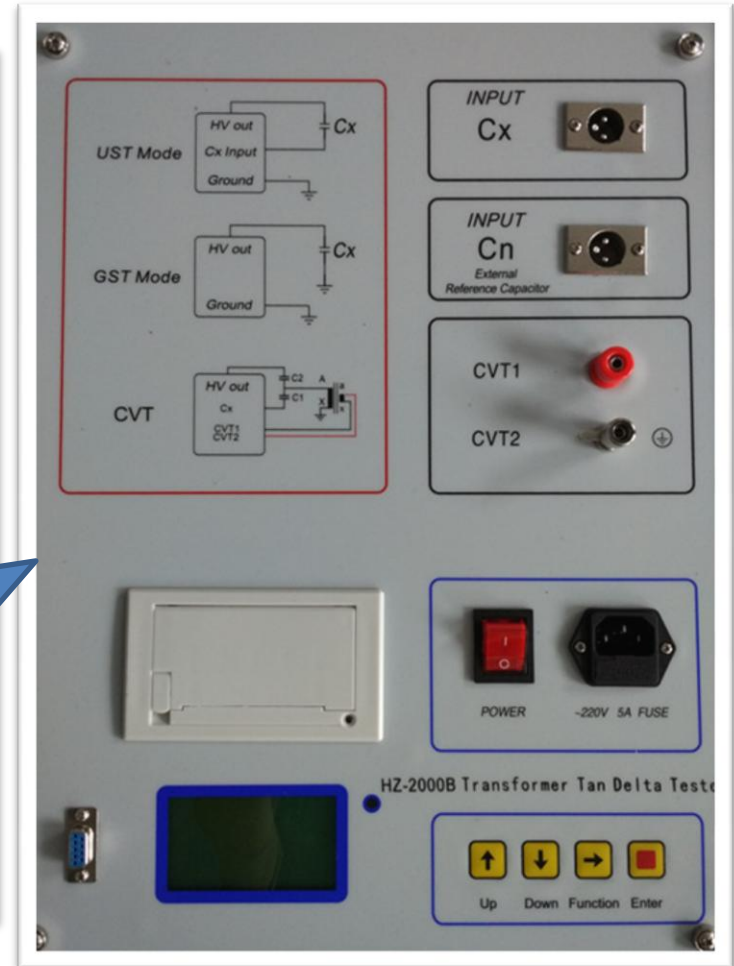
Tan-Delta and Capacitance testing can detect deteriorated bushing insulation
